Docket No. 50-443

NYN-99004

Seabrook Station
Licensee Event Report (LER) 98-014-00
Reactor Trip Due to Pole Disagreement on 345 kV Breaker

REACTOR TRIP DUE TO POLE DISAGREEMENT ON 345 kV BREAKER

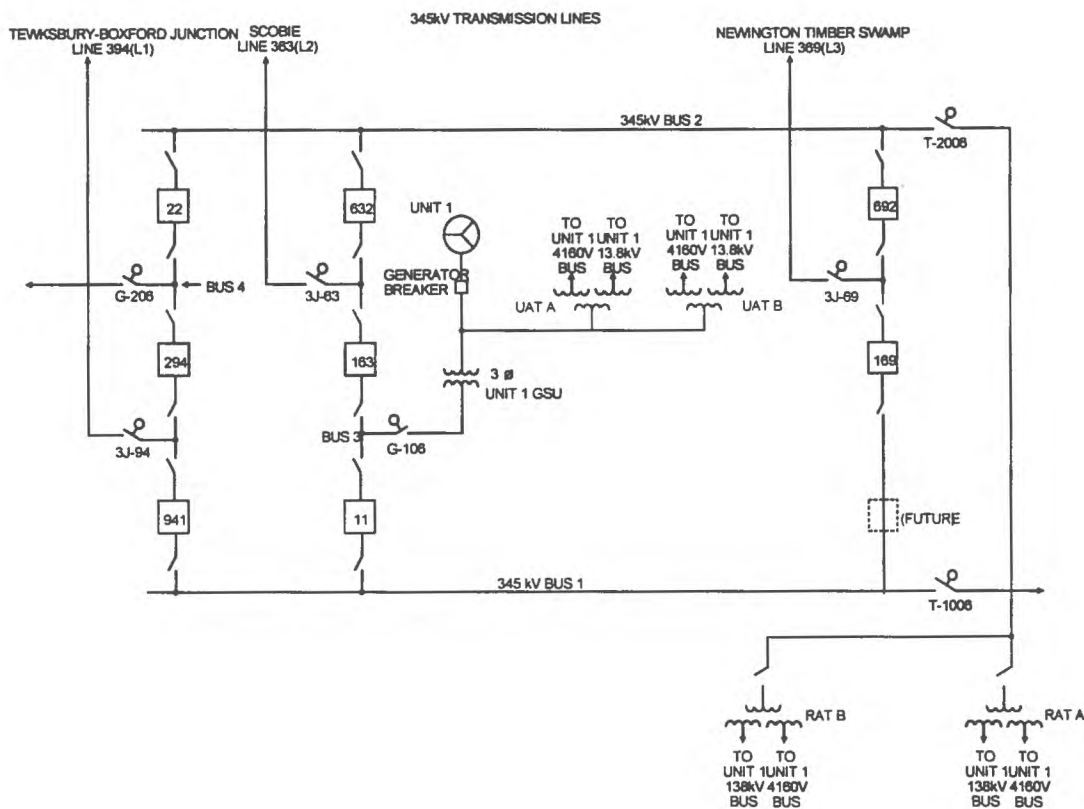
345 kV Switching Station One-Line Diagram

The event occurred when breaker 163 was opened for routine offsite line maintenance. All three poles opened but the auxiliary switch for pole "C" did not actuate. This caused a pole disagreement to be detected in breaker 163. The breaker failure circuitry then sent trip signals to 345 kV breakers 11, 632, the main generator breaker, the six Unit Auxiliary Transformer (UAT) [EA] feeder breakers for Buses 1 through 6, and other miscellaneous breakers. This resulted in a loss of turbine load and caused a turbine trip and subsequent reactor trip. It also initiated a UAT to Reserve Auxiliary Transformer (RAT) [EA] transfer on Buses 1 through 6 as expected when the UAT supply breakers trip. (Refer to Figure in LER Section V).
